MTS '92

## THE INFLUENCE OF METALLURGY ON MICROBIOLOGICALLY INFLUENCED CORROSION

Patricia Wagner and Brenda Little

In the study of microbiologically influenced corrosion (MIC) of metals there is an interrelationship between the metallurgical character and composition, the electrolyte, and bacterial species. Basic mechanisms of MIC, examples, and influence of metallurgical factors are reviewed.

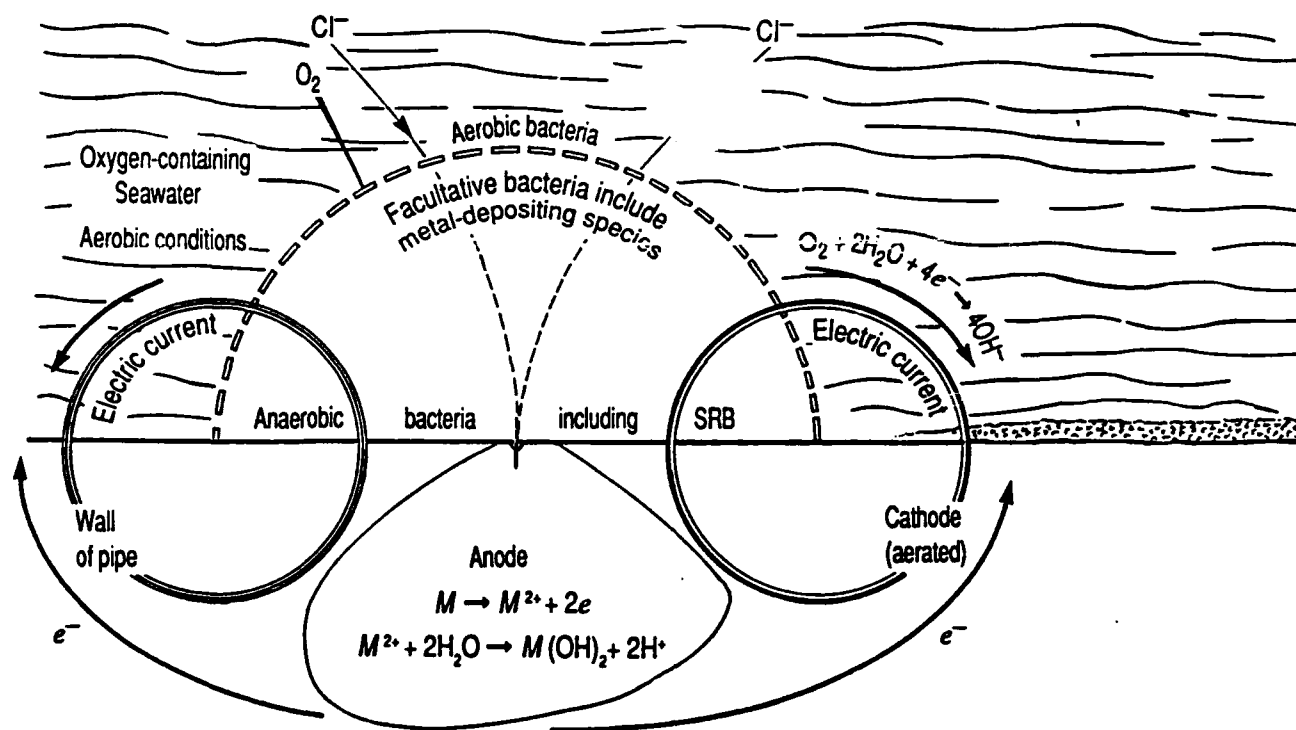
Figure 1. Reactions possible under tubercles created by metal-depositing bacteria.

Metal-depositing organisms, important in MIC of stainless steels, may catalyze the oxidation of metals, accumulate abiotically oxidized metal precipitates, or derive energy by oxidizing metals. The dense deposits of cells and metal ions create oxygen concentration cells that effectively exclude oxygen from the area immediately under the deposit. Underdeposit corrosion is extremely important because it initiates a series of events that are, individually or collectively, extremely corrosive.<sup>7</sup> Figure 1 shows reactions possible under tubercles created by metal-depositing bacteria. In an oxygenated environment, the area immediately under the deposit is deprived of oxygen. That area becomes a relatively small anode compared to the large surrounding oxygenated cathode. Cathodic reduction of oxygen may result in an increase in pH of the solution in the vicinity of the metal. The metal will form metal cations at anodic sites.

If the metal hydroxide is the thermodynamically stable phase in the solution, the metal ions will be hydrolyzed by water with the formation of  $H^+$  ions. If the cathodic and anodic sites are separated from one another, the pH at the anode will decrease and that at the cathode will increase. The pH within the anodic pit depends on specific hydrolysis reactions.<sup>8</sup> The lowest pH values are predicted for alloys containing chromium and molybdenum. For this reason, underdeposit attack is particularly aggressive on stainless steels. In addition,  $Cl^-$  ions from the electrolyte will migrate to the anode to neutralize any buildup of charge, forming heavy metal chlorides that are extremely corrosive.<sup>8</sup> Under these circumstances, pitting involves the conventional features of differential aeration, a large cathode:anode surface area and the development of acidity and metallic chlorides. These environments also harbor obligately anaerobic SRB and acid-producing bacteria.
